SHOCK TUNNEL TESTS OF WALL PANELS

TECHNICAL REPORT

Volume I

Test Information
and
Analysis

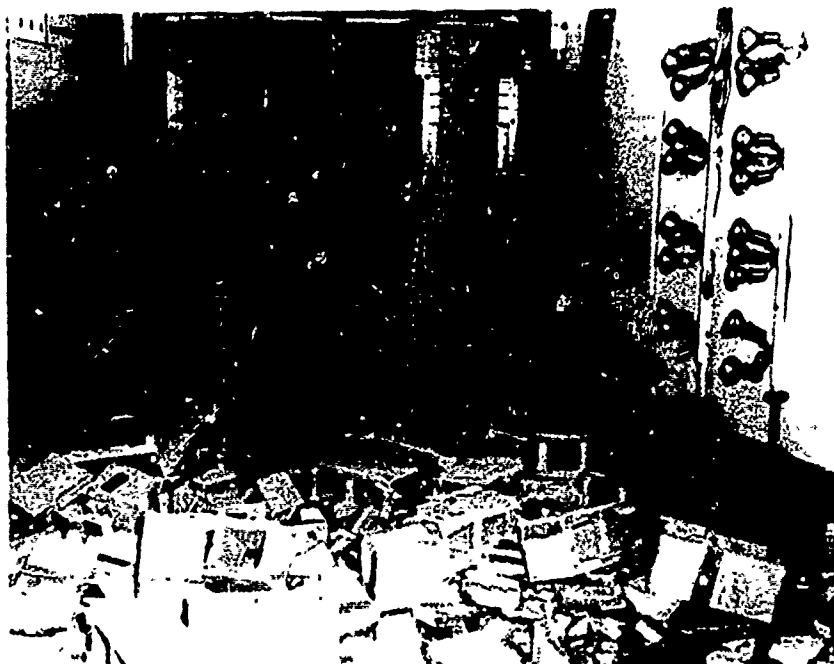
Fig. 6-8. Post-Test Photographs, Wall No. 59, Nonreinforced Concrete Block Interior Wall (Test No. 05-26-71-02)

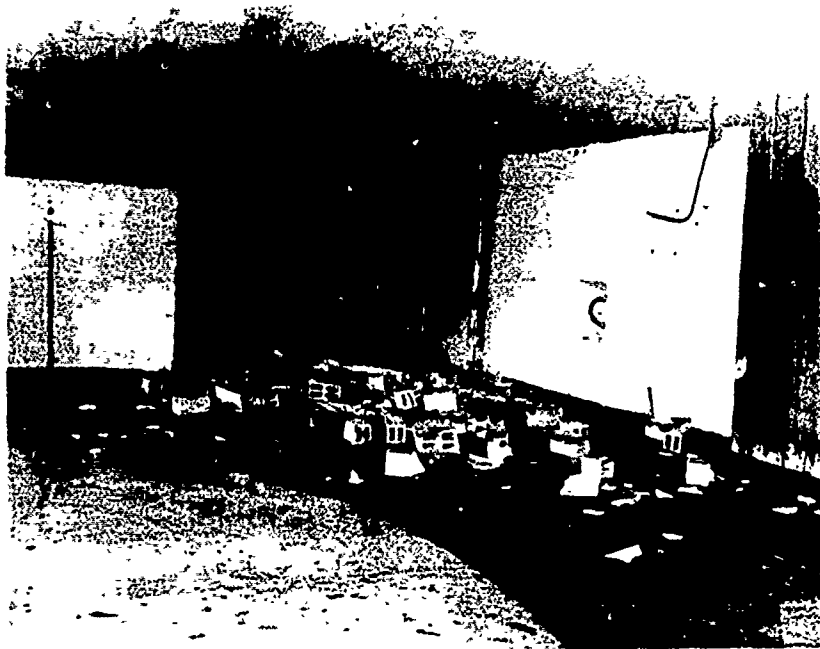
Fig. 6-11. Post-Test Photographs, Wall No. 62, Nonreinforced Hollow Clay Tile Interior Wall (Test No. 05-23-71-02)

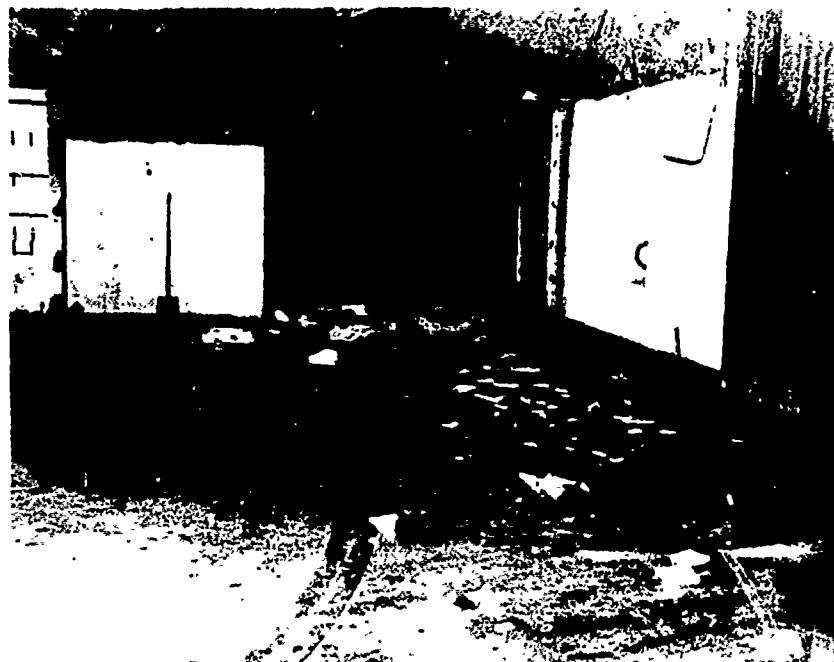
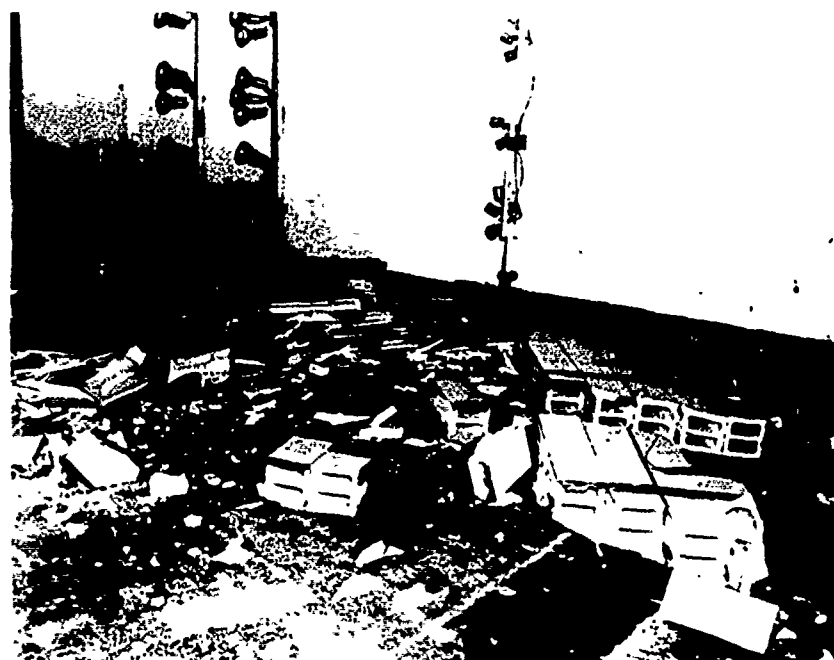
Fig. 6-12. Post-Test Photographs, Wall No. 63, Nonreinforced Hollow Clay Tile Interior Wall (Test No. 05-28-71-02)
